HOLLIDAY CREEK, WICHITA FALLS, TEXAS LOCAL FLOOD PROTECTION

SPILLWAY FOUNDATION REPORT

DECEMBER 1997

U.S. ARMY ENGINEER DISTRICT, TULSA CORPS OF ENGINEERS TULSA, OKLAHOMA

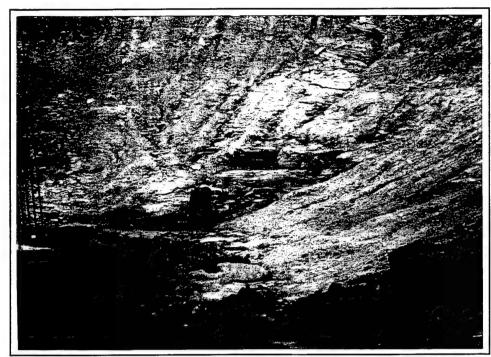
Photo 5. Wet spot on the left side of the spillway at fracture in the sandstone.

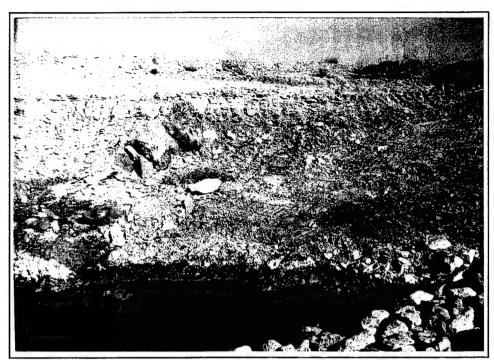
Slickensiding (not due to equipment) was observed in the shale. The clay shale also exhibited jointing with no discernible bed displacement, possibly being ancient desiccation cracks. There appears to be a displacement in the base of the sandstone on the right side of the spillway excavation at station 413+30 and also on the left side of the excavation at station 415+56. There were wet spots near each of these displacements. The upstream wet spot is located on the left side of the spillway (northwest), approximate station 415+46, 130 feet left of the spillway centerline. The spot is about 5 feet above the floor excavation and is moist around several cracks and appeared to flow where they coalesced (see photos 3 through 5). This was a minor problem during construction as the weather was dry. The upstream wet spot is about 200-250 feet from the lake and below the lake level. The downstream wet spot was located on the right side of the spillway, approximate station 413+30, 100 feet right of centerline, and had a pump in it most of the time. This wet spot seems to be where the sandstone butts up against a dark shale. The sandstone may be a stream channel deposit and the wet spot may be from a pond just uphill and off the property, (see photos 6 through 8).

Photo 7. Area above wet spot on the right side of the spillway after some detritus removed. Note wet sections in sandstone on left and center of photo.

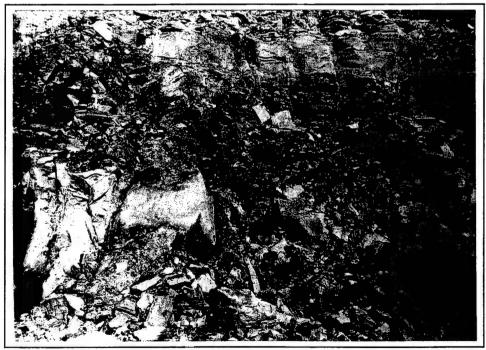
Photo 8. Close-up of area near the center of photo 7.

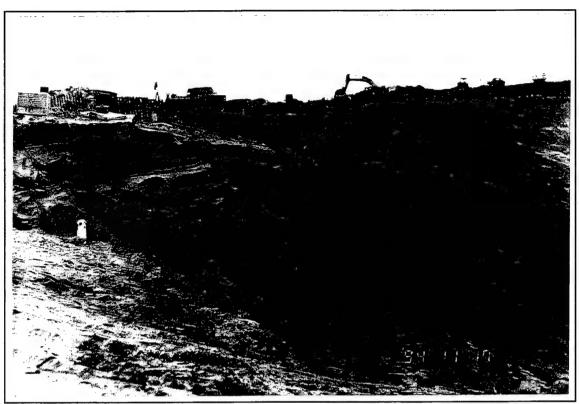
Photo 12. Vertical cut in spillway excavation 44 feet left of centerline, Station 415+90 to 416+00. Note the relationship of the different rock strata within the cut.

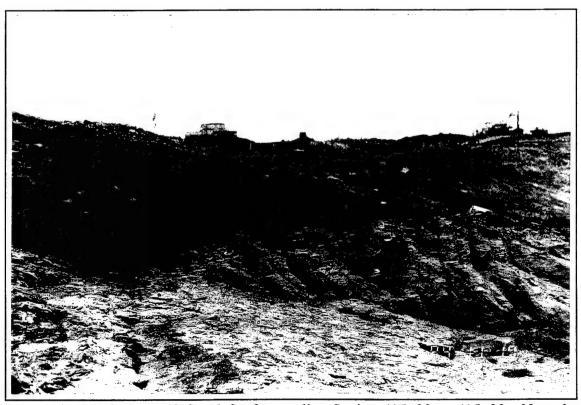
Photo 13. Vertical cut 43 feet left of centerline Station 415+80 to 415+90. Note the same relationships as in photo 12. Red claystone is common in both areas.

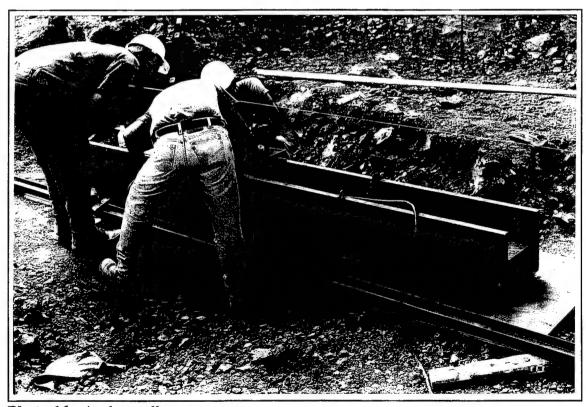
Photo 16. Anchor pullout test.

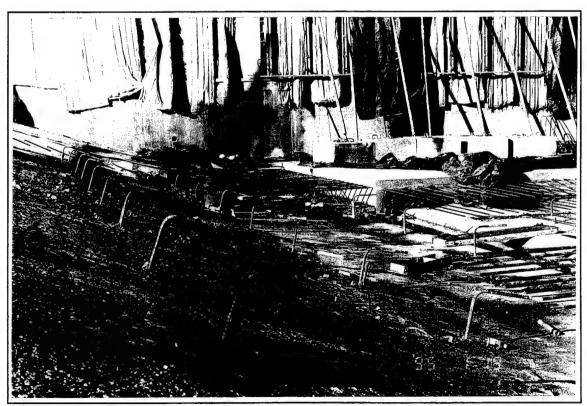
Photo 18. Inplace anchors.
